Manhole Inspection Summary

Manhole # S39EE_015MH

Insp Date: **10/22/07 4:03 PM**

Location Address: **1101 WILLINGER CT**

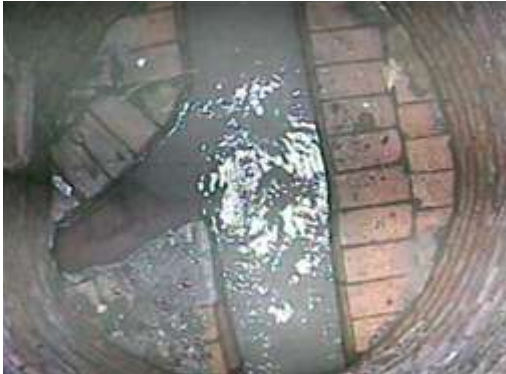
Defect 2

Count: **5** Missing: **3** ☒ **Corroded**

☒ **Evidence Of Surcharge** Depth: **2** (ft.) ☐ Active Surcharge Present

evidence surcharge and corroded step

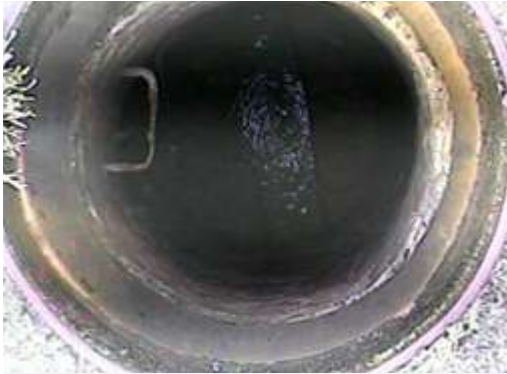
Defect 1

loose bricks frame adjustment

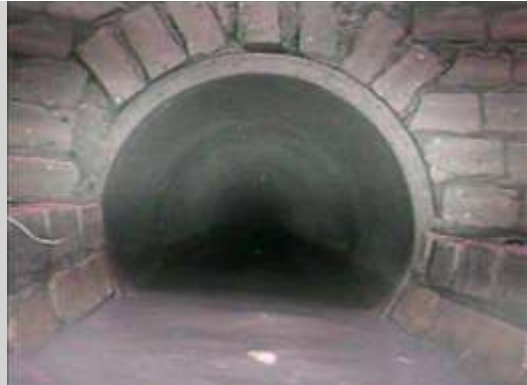
12 O'Clock Outflow

15 in. Circular Gravity Sewer
Pipe Out @ 12 O'Clock

Pipe Height: **10.8** (in.) Rod and Bar
Pipe Material: **Clay** ☐ Pipe Lined
Invert Depth: **9.21** (ft.) Flow Characteristics: **Fast**
Deposits: ☒ None ☐ Mud ☐ ~~Gravy~~ ☐ Debris ☐ Grease
Silt Depth: (in.) Deposits Extent:
Infiltration: **None** Pipe Seal Cond: **Sound**

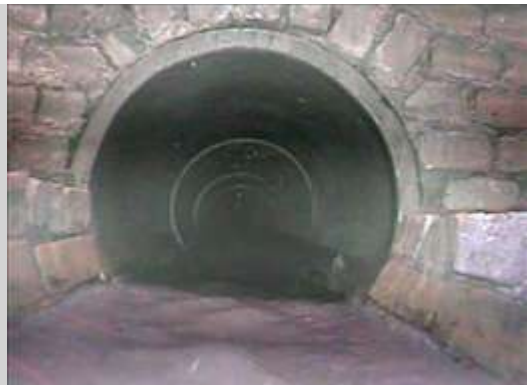
6 O'Clock Inflow

15 in. Circular Gravity Sewer
Pipe In @ 6 O'Clock

Pipe Height: **12** (in.) Rod and Bar
Pipe Material: **Clay** ☐ Pipe Lined
Invert Depth: **9.22** (ft.) Flow Characteristics: **Fast**
Deposits: ☒ None ☐ Mud ☐ ~~Gravy~~ ☐ Debris ☐ Grease
Silt Depth: (in.) Deposits Extent:
Infiltration: **None** Pipe Seal Cond: **Sound**

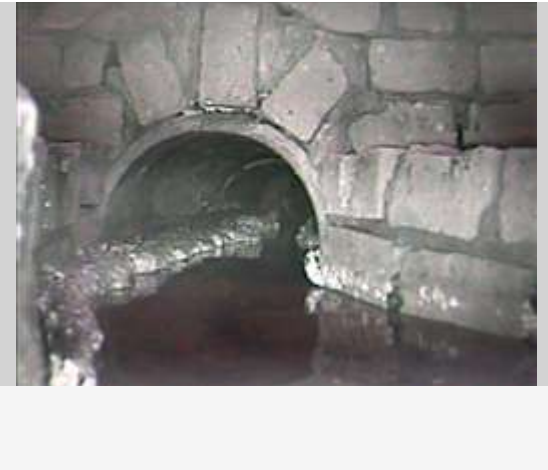
9 O'Clock Inflow

8 in. Circular Gravity Sewer

Invert Depth: **9.16** (ft.) Flow Characteristics: **Slow**

Deposits: ☐ None ☐ Mud ☒ **Sludge** ☐ Debris ☒ **Grease**

Silt Depth: **2** (in.) Deposits Extent: **Light**
